Appendix F

Photograph Log

Outfall Site Visits

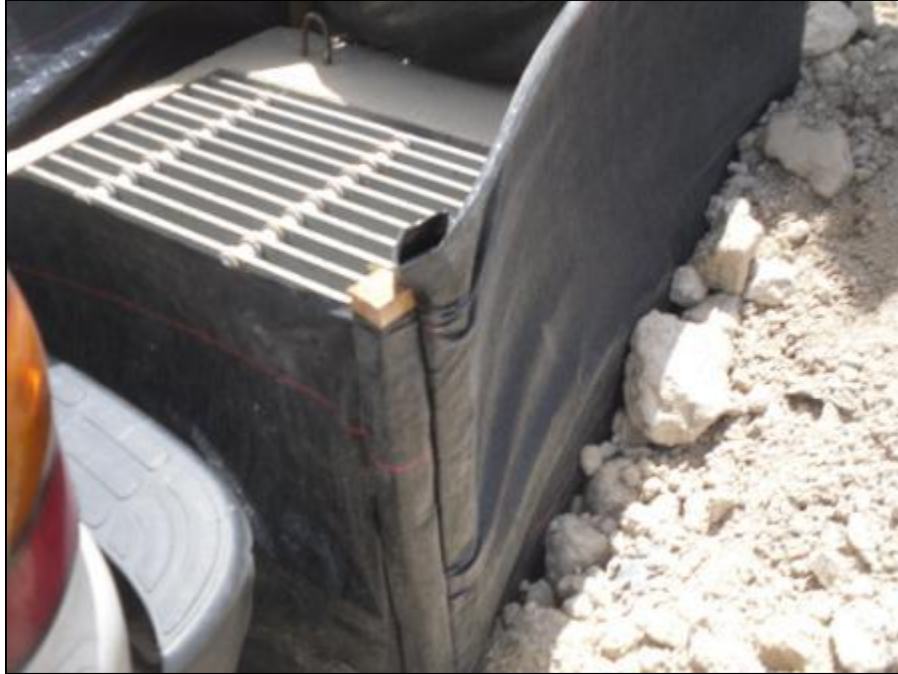
Photograph 74. View of a newly installed storm drain inlet surrounded by silt fence. Note that the ends of the silt fence are not wrapped around each other.

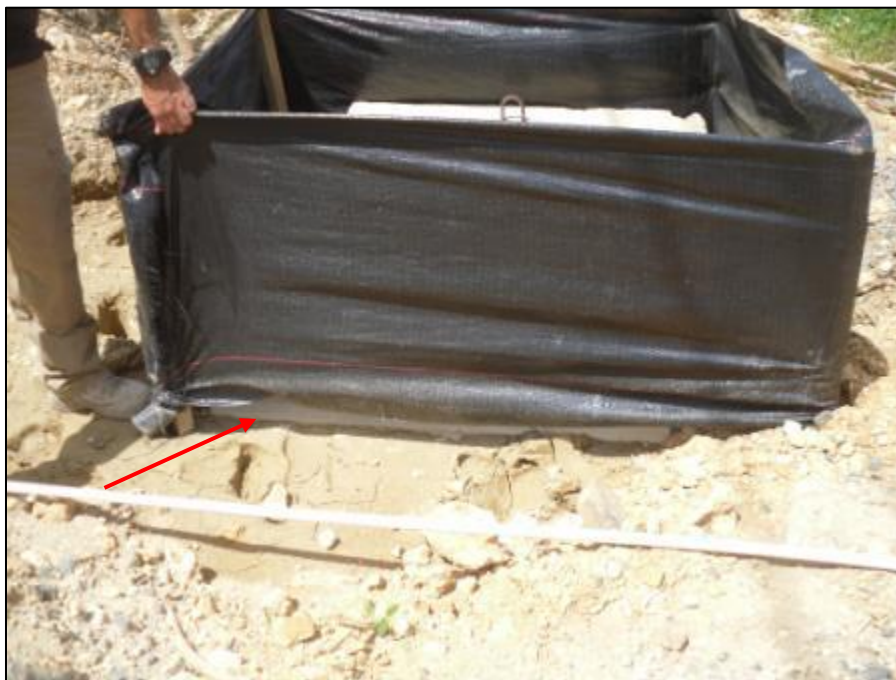
Photograph 77. Closer View of the storm drain inlet shown in Photograph 76. Note that the silt fence was not entrenched.

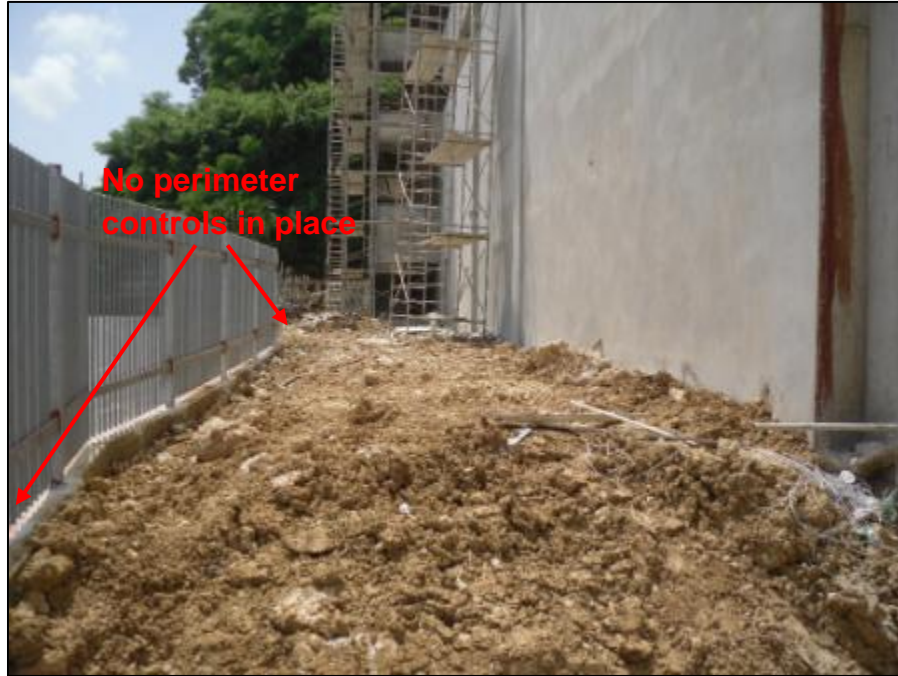
Photograph 80. View of disturbed earth along the fence line of PR-167 immediately north of the southeast corner of the construction site. Note that no perimeter controls are present along the fence line.

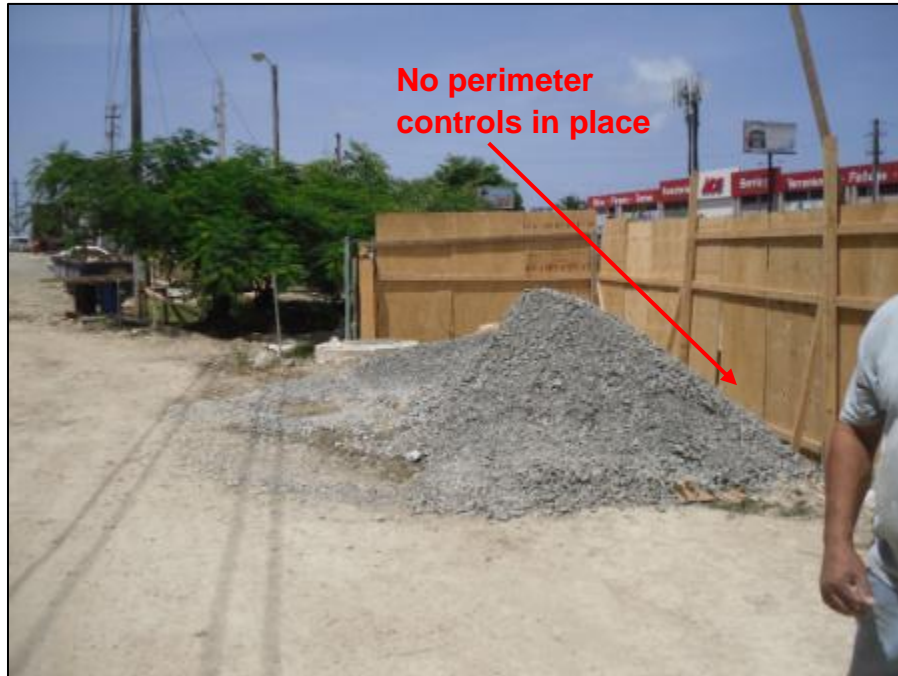
Photograph 82. View of a gravel stockpile located along the fence line of PR-167 immediately south of the construction entrance to PR-167. Note that no perimeter controls are present along the fence line.

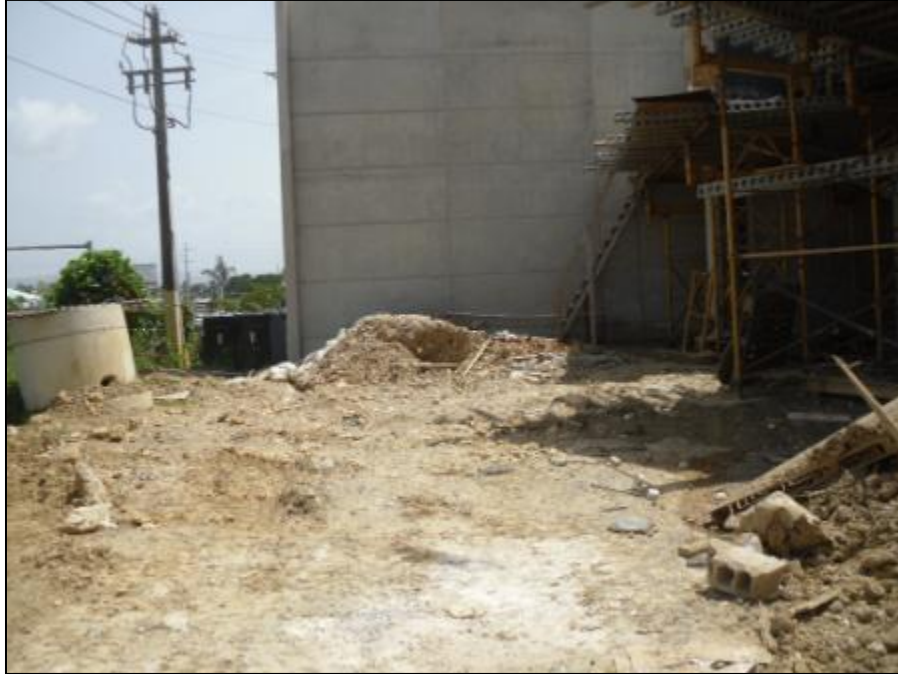
Photograph 86. View of a stockpile of material and scattered debris located immediately to the south of the construction entrance to PR-167 and to the north of the hotel and casino building.

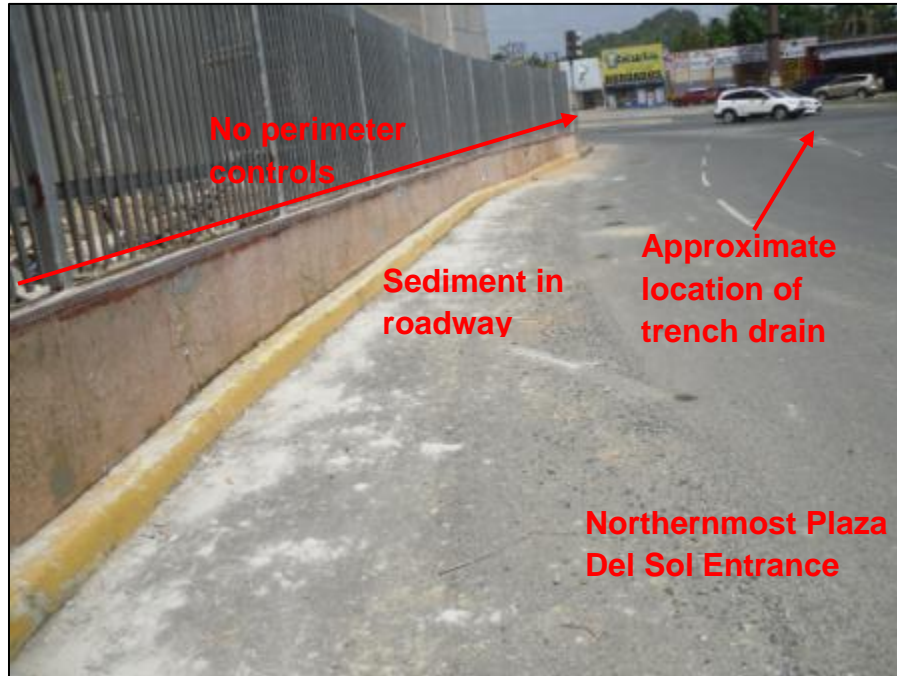
Photograph 88. Exterior view of the northern most entrance to Plaza Del Sol located immediately to the south of the site. Note lack of perimeter controls along the interior fence line and that sediment was observed in the curb and gutter, and in the trench drain across the entrance to Plaza Del Sol (arrow indicates approximate location of trench drain).

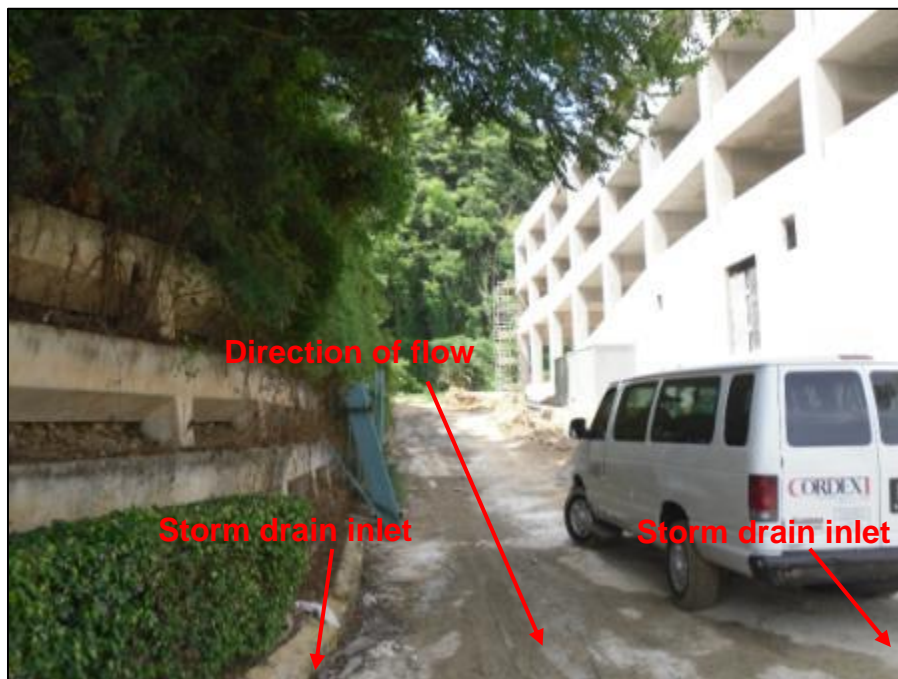
Photograph 91. View of two storm drain inlets at the southern construction site entrance adjacent to the northern most entrance to Plaza Del Sol. Note the location of the storm drain inlets, and that there was track out from construction equipment and vehicles.

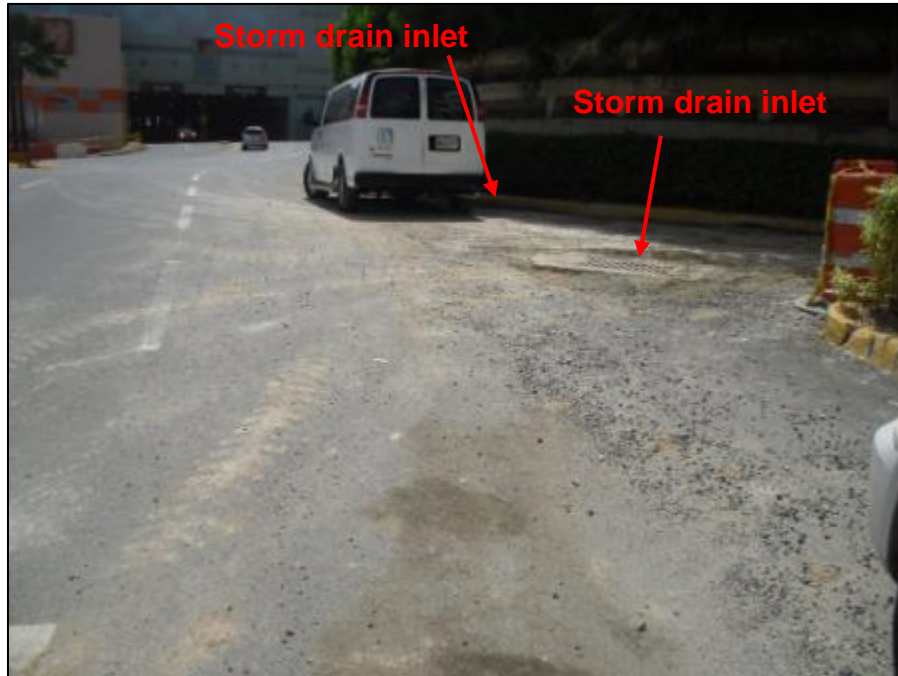
Photograph 92. Alternate view of two unprotected storm drain inlets at the southern construction site entrance adjacent to the northern most entrance to Plaza Del Sol. Note the location of the storm drain inlet, and that there was track out from construction equipment and vehicles.

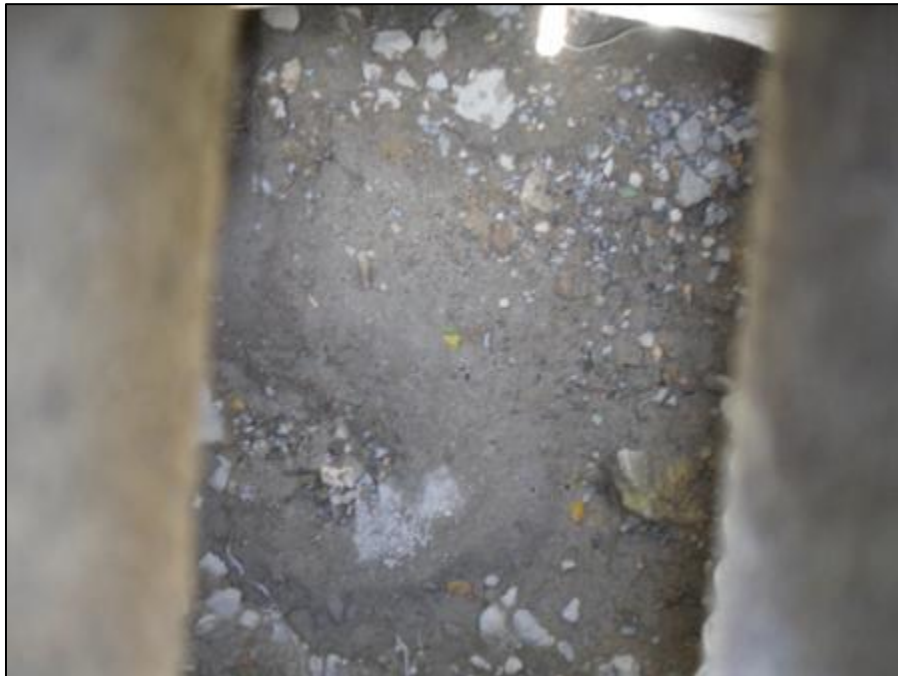
Photograph 93. View inside the storm drain inlet shown on the right in Photograph 92. Note the sediment and debris in the structure.

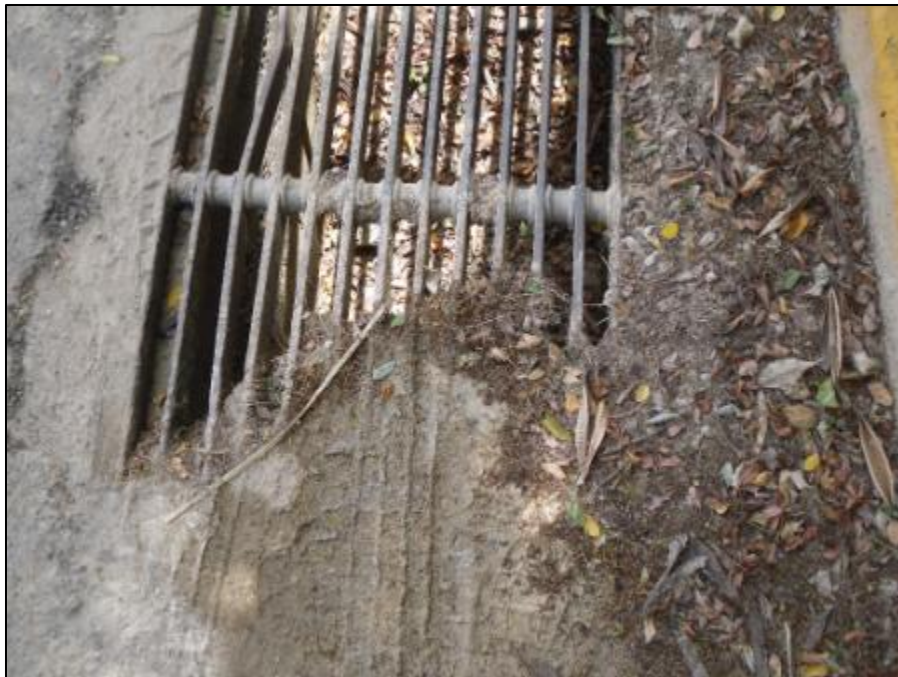
Photograph 95. View of the storm drain inlet shown in Photograph 94. Note the sediment and debris in the structure.

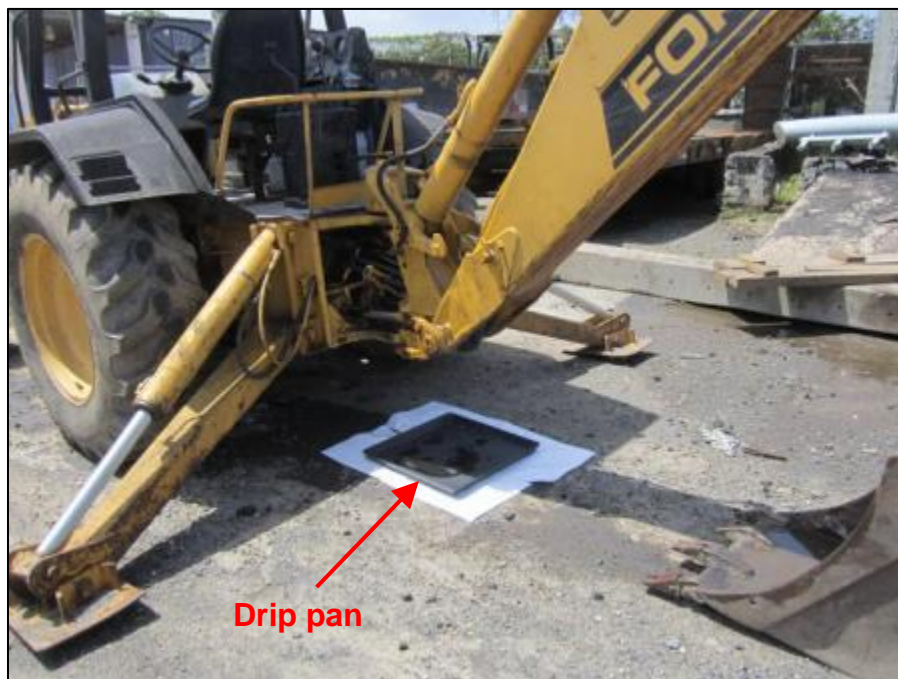
Photograph 100. View of drip pan placed beneath an active leak from a piece of equipment at the facility.

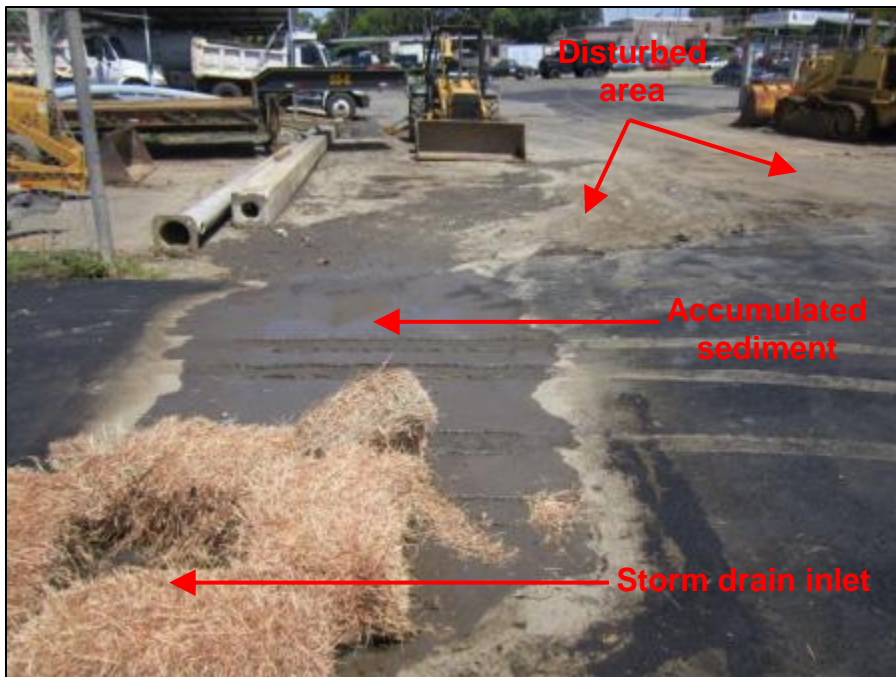
Photograph 103. View of disturbed area and accumulated sediment upgradient and adjacent to a storm drain inlet in the central portion of the facility.

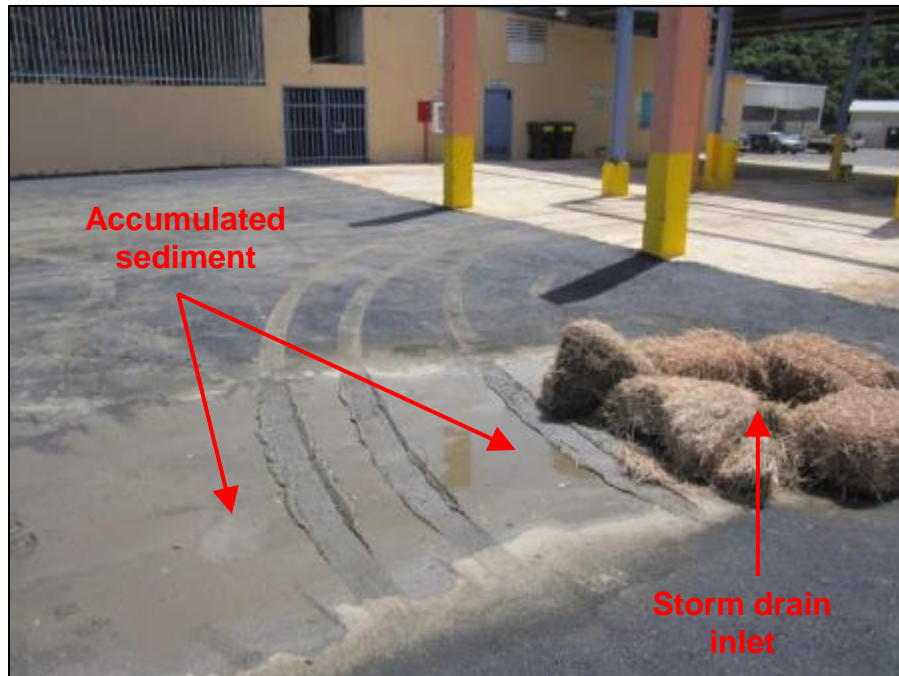
Photograph 104. Additional view of accumulated sediment and storm drain inlet displayed in previous photograph.

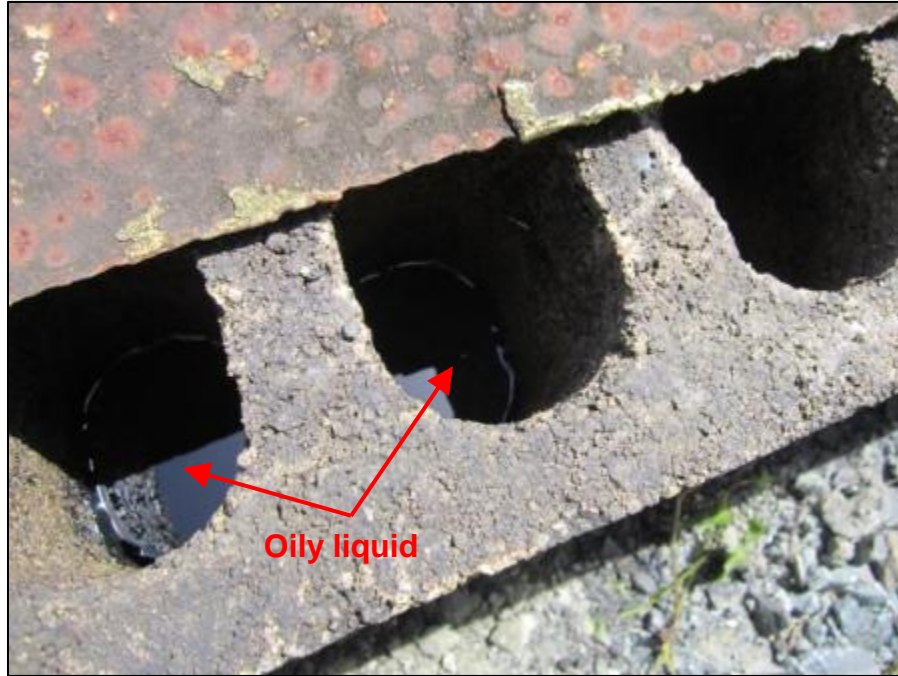
Photograph 110. View of oily liquid accumulated within the holes of the cinder blocks denoted in Photographs 107 and 108.

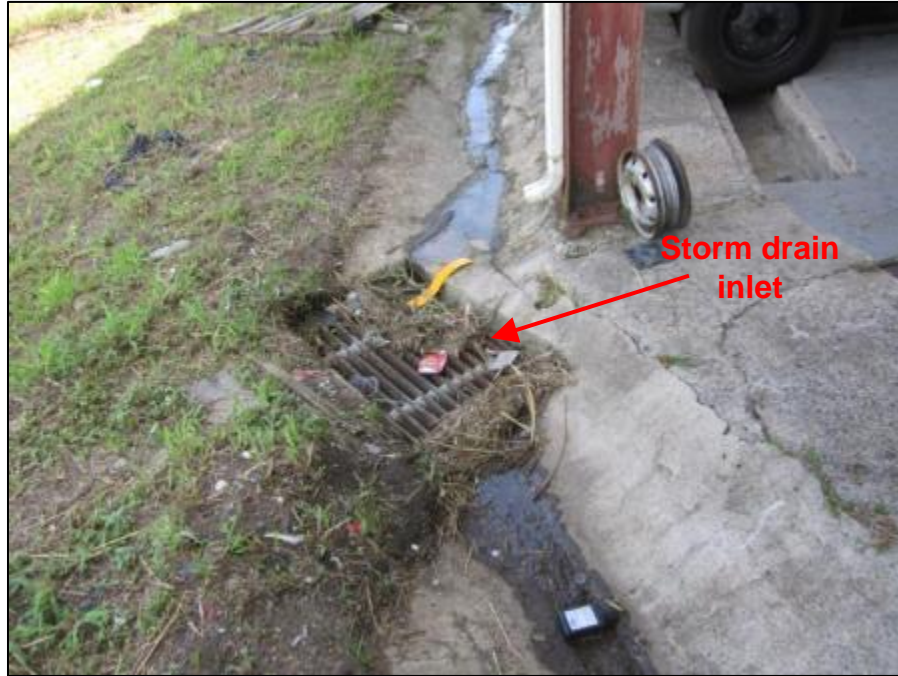
Photograph 112. View of storm drain inlet near vehicle washing area in northern portion of the facility. Note trash and debris adjacent to and on the storm drain inlet.

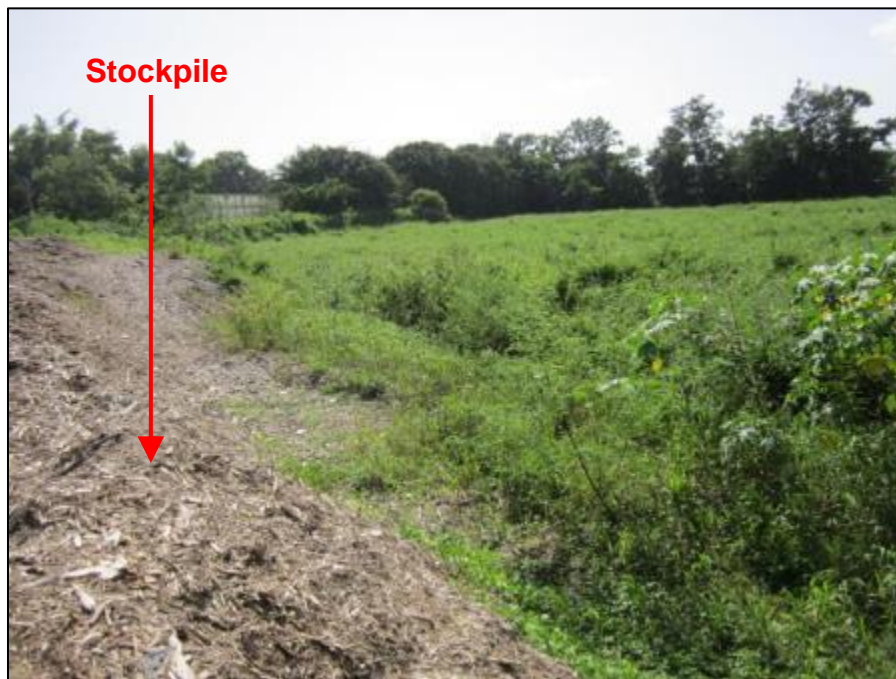
Photograph 114. View of northern perimeter of vegetative debris stockpile. Note lack of perimeter control BMPs.

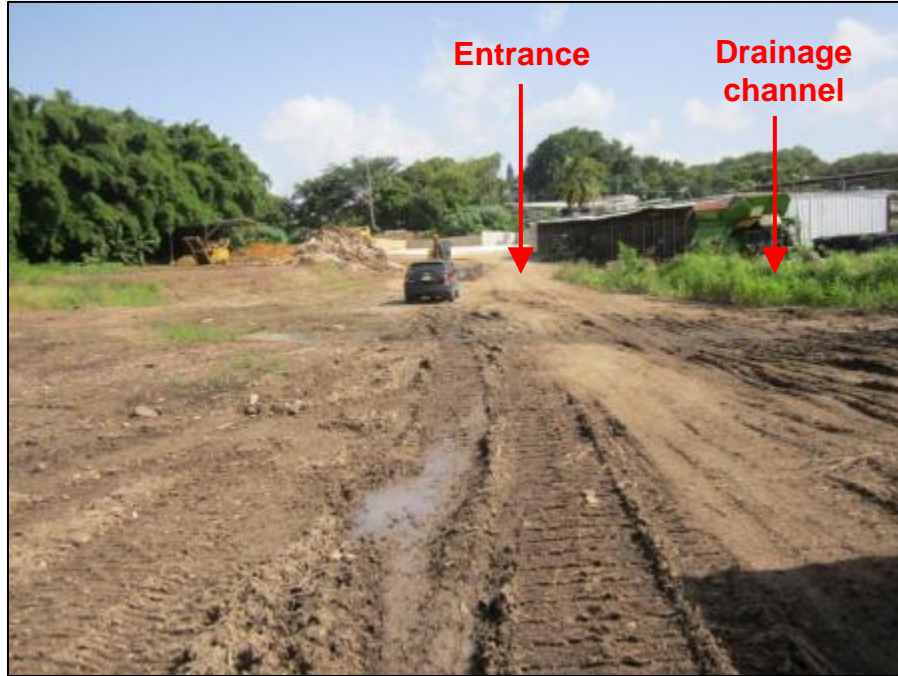
Photograph 115. View to south of unstabilized entrance to vegetative debris stockpile.

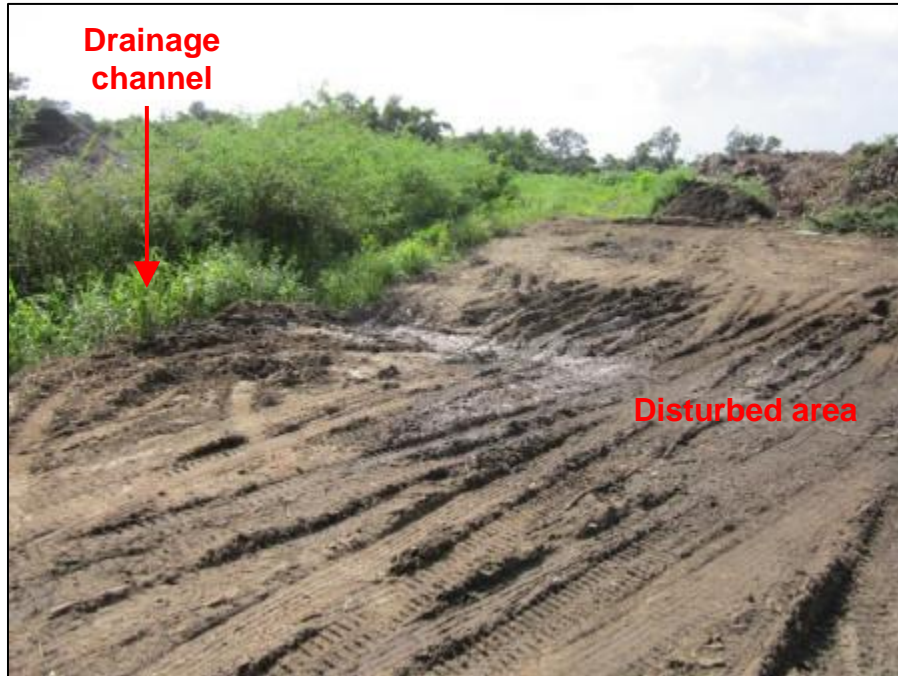
Photograph 117. Closer view of unstabilized entrance and adjacent drainage channel shown in Photograph 115.

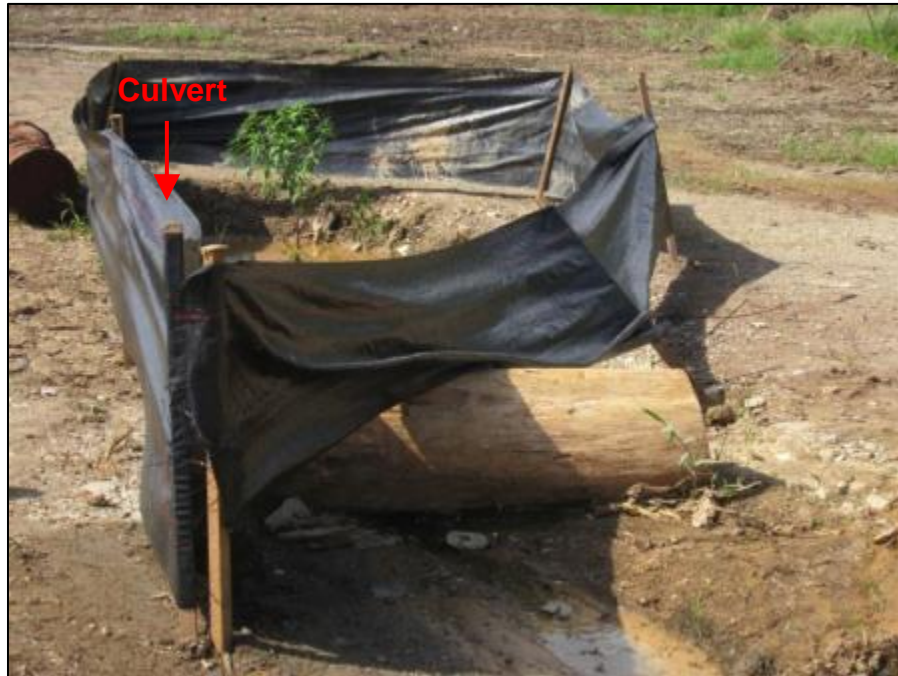
Photograph 121. View of silt fence installed around drainage channel and culvert. Note silt fence is not entrenched into ground and there is a log underneath a portion of the silt fence.

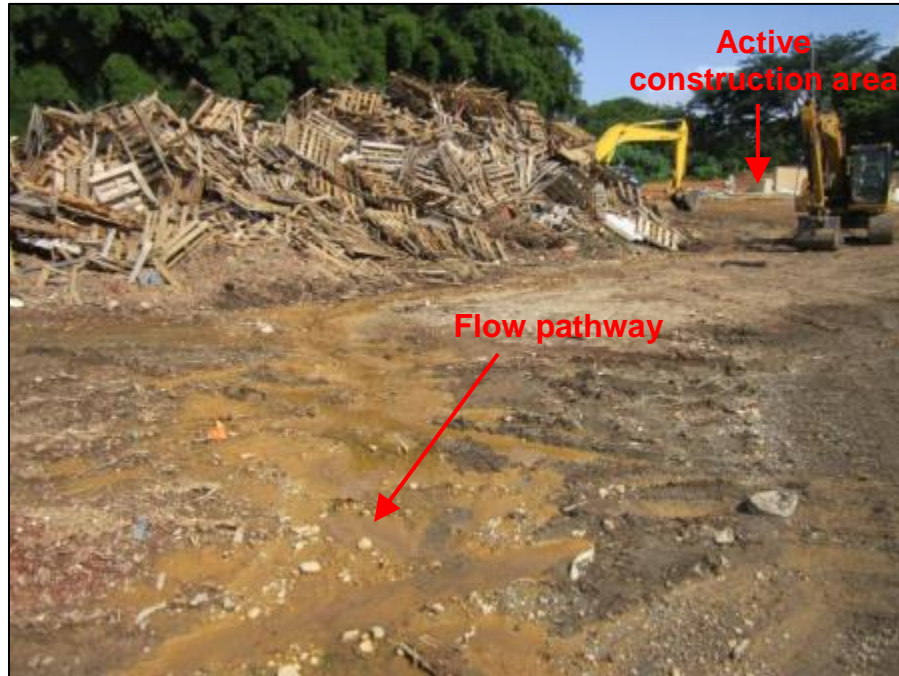
Photograph 123. View of area directly upgradient of silt fence shown in previous photograph. Note flow pathway through upgradient disturbed area.

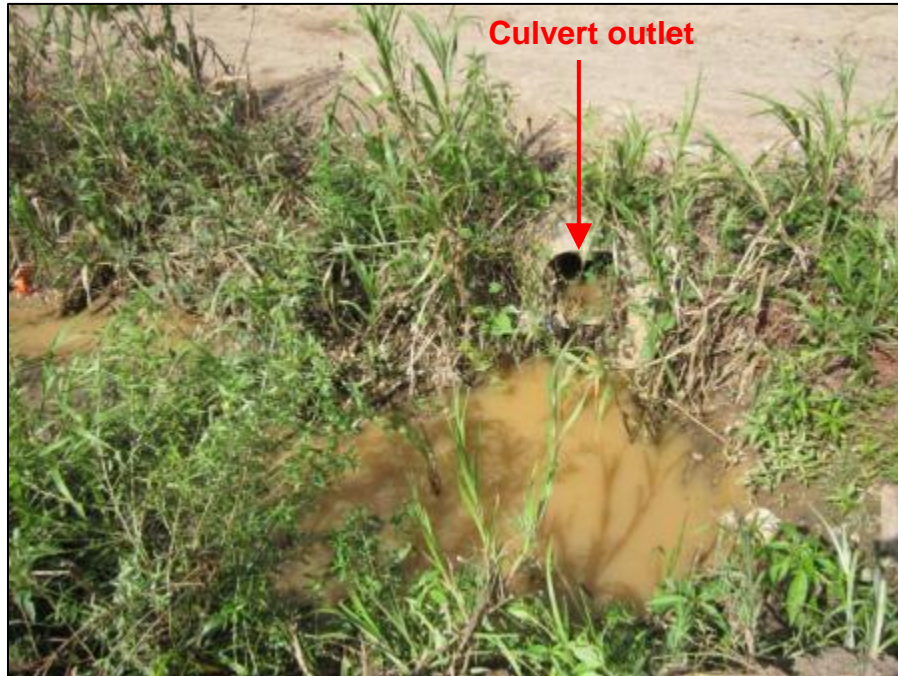
Photograph 125. View of culvert outlet and sediment-laden water downgradient of the culvert.

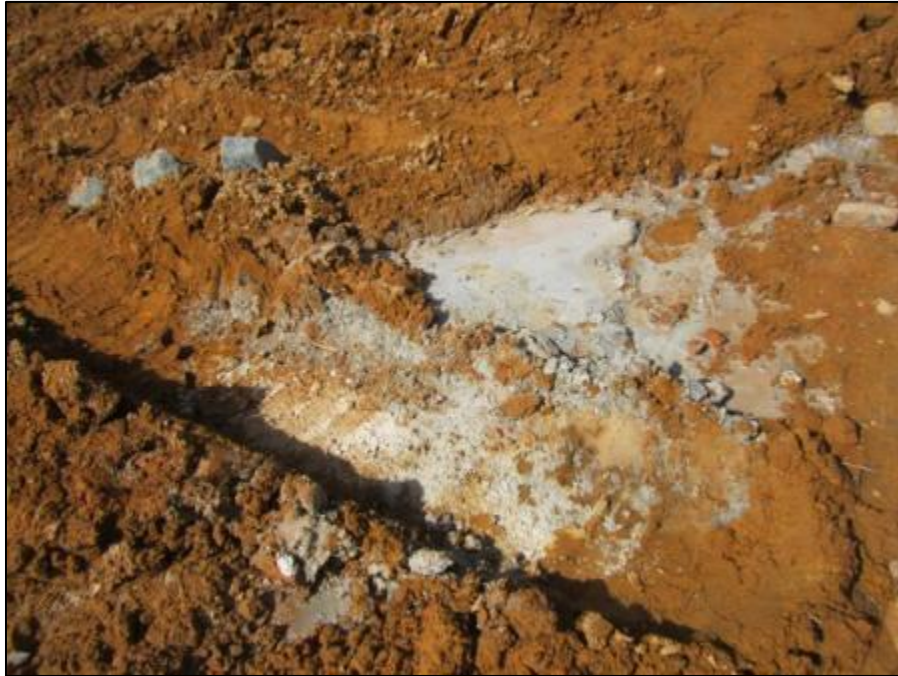
Photograph 127. Additional view of concrete waste on ground in active construction area.

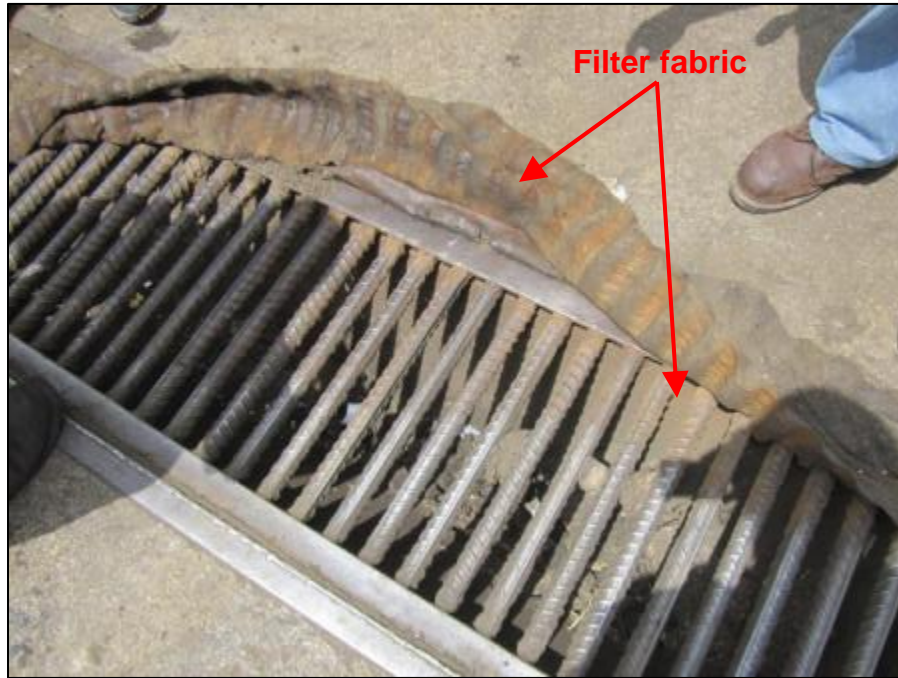
Photograph 134. Closer view of trench drain shown in previous photograph. Note filter fabric material within trench drain.

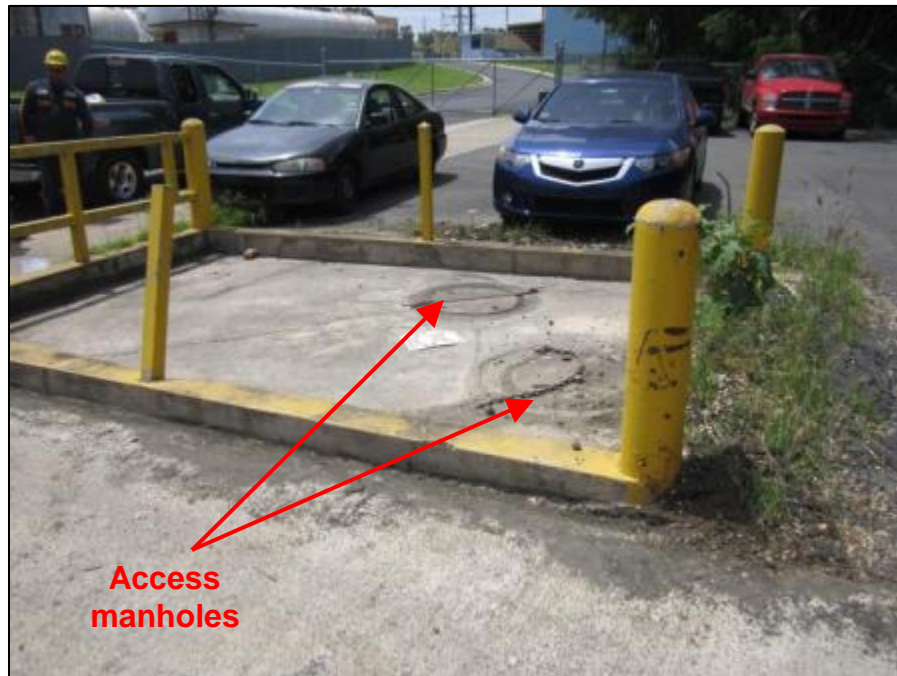
Photograph 136. View of area with underground pollutant removal device adjacent to facility entrance.
